BYRAM TOWNSHIP MUNICIPAL BUILDING ASSESSMENT

9/11/15

EXECUTIVE SUMMARY:

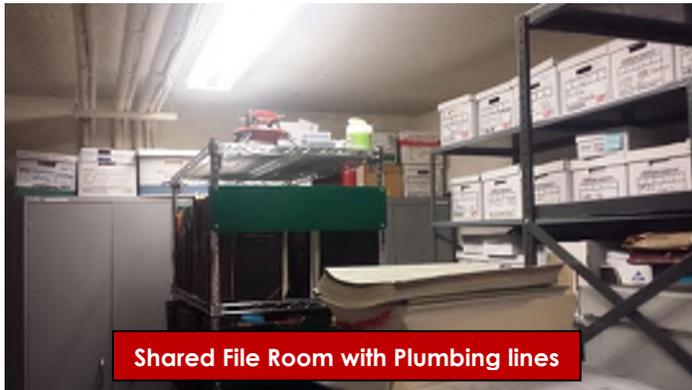
Shared File Room with Plumbing lines

An old vault currently serves as a shared storage space. All finishes in the room should be replaced with new, and an organized shelving/file system installed to properly store all documents and records. Adequate storage/file spaces are needed throughout the entire Municipal Building. Some of these storage areas should be located within each department, and other shared storage spaces should be provided for long term storage.

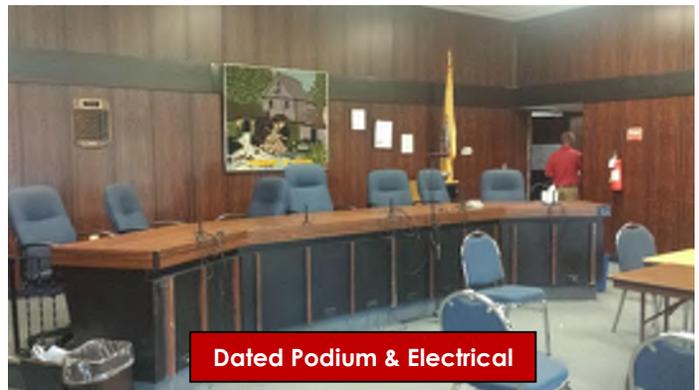
Dated Podium & Electrical

The Council Chamber is located to the right side of the building entry. The Council Dais is approximately 6" above the rest of the floor, however, there is no accessible route to the Dais. The existing podium is dated, and should be replaced, and if the room is converted back to dual-use as a Court Room, a new podium with a ballistic shield for the Judge would be required. All of the finishes in the room appear original to the building and should be upgraded or replaced, including the following:

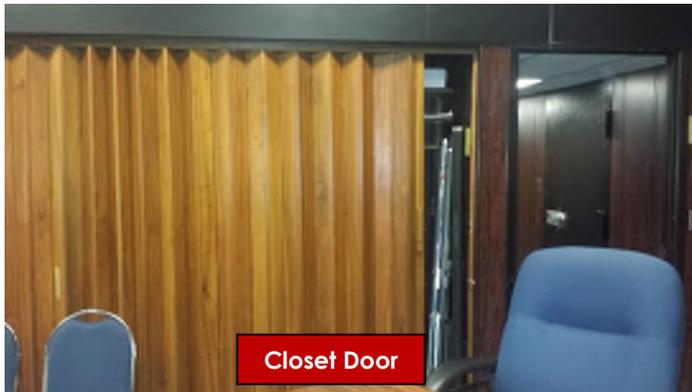
Closet Door

- ✚ The accordion doors on the closet are in poor condition and should be replaced.
- ✚ The audio and visual systems in the Council Chamber should be replaced with the latest technology.

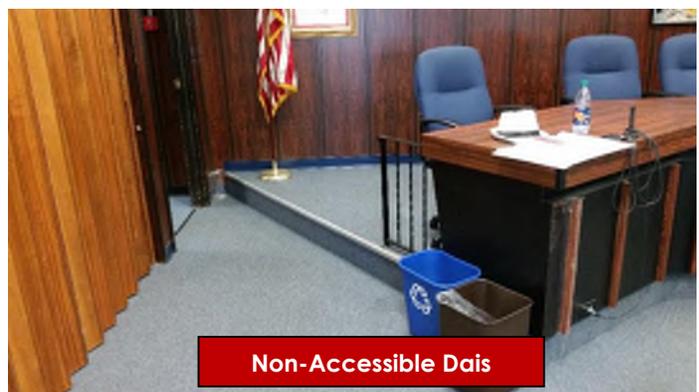
Non-Accessible Dais

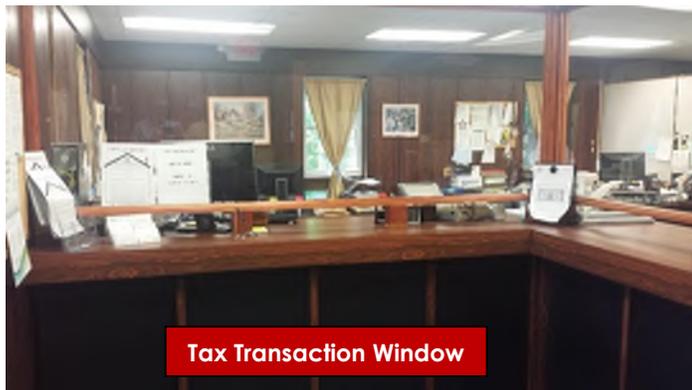
The Finance/Tax Department is located to the left side of the entry. There is a makeshift transaction counter that was constructed to handle processing paperwork with the public and collecting Tax. This transaction window should be replaced with a new window, and counter, with ballistic glazing. The finishes, furniture, and partitions in this area should all be replaced, including the following:

Tax Transaction Window

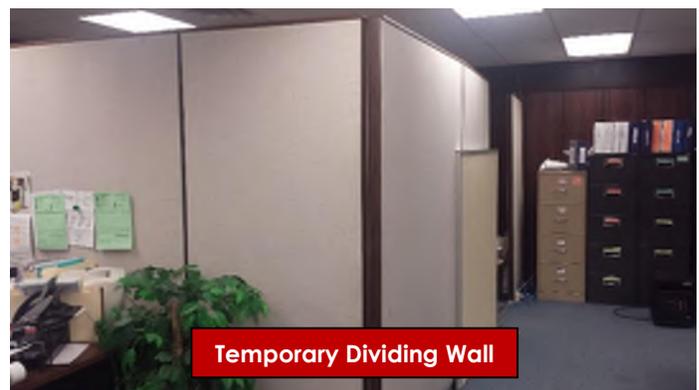
Temporary Dividing Wall

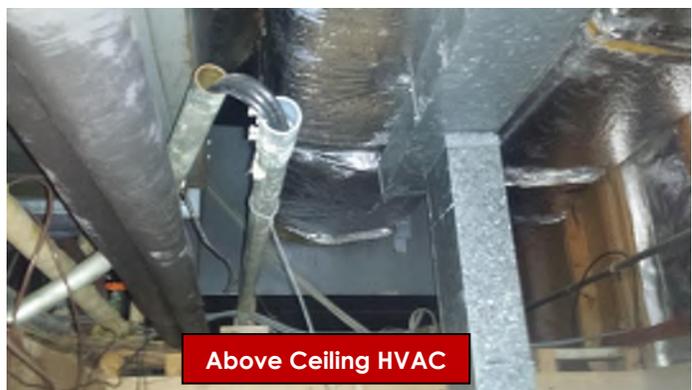
Above Ceiling HVAC

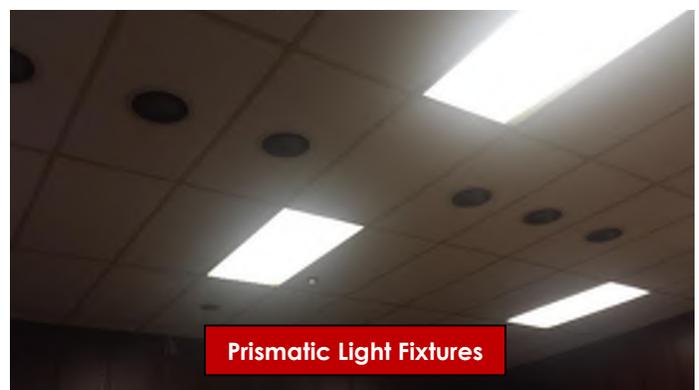
Prismatic Light Fixtures

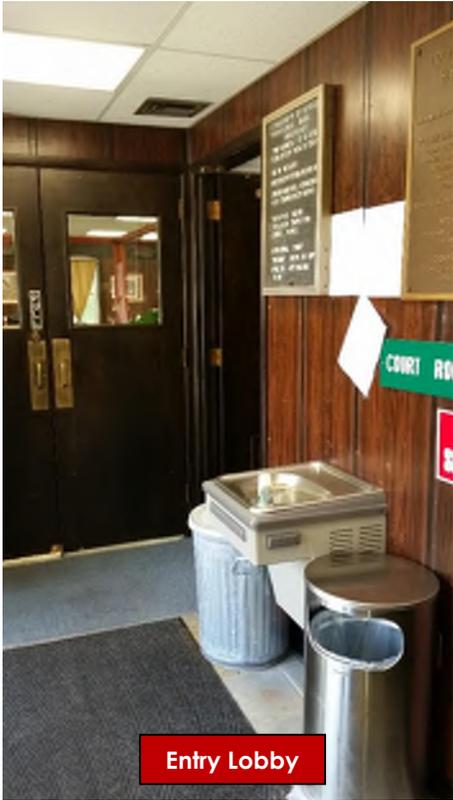
Entry Lobby

- ✚ The old Quarry Tile floor needs to be replaced.
- ✚ The original wood paneling on the walls needs to be refinished or replaced.
- ✚ The existing drinking fountain obstructs much of the little space available.
- ✚ The existing aluminum and glass storefront is constructed of single pane glass and has minimal insulating capabilities. This storefront should be replaced with insulating glass units, and thermally broken aluminum frames.
- ✚ The existing suspended acoustical ceiling is beyond its useful life and should be replaced.
- ✚ The existing fluorescent lighting should be replaced with energy efficient lighting.

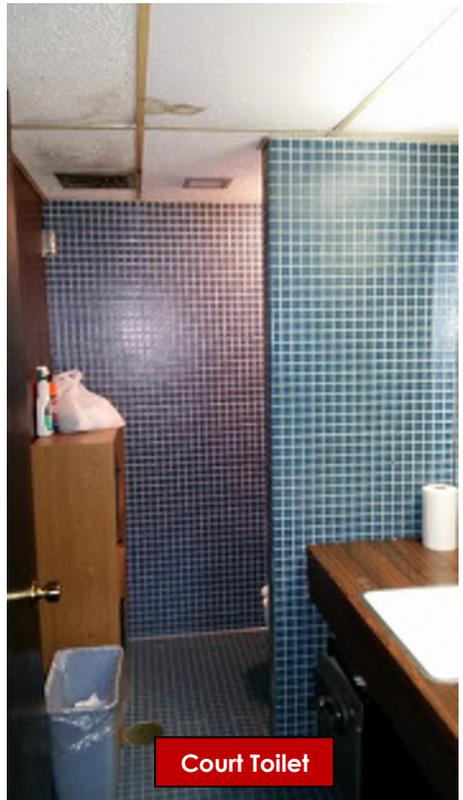
- ✚ There is a single stall toilet, within the Court Office, which is in poor condition and should be completely renovated with all new finishes and fixtures. This toilet is not ADA Compliant.

Court Toilet

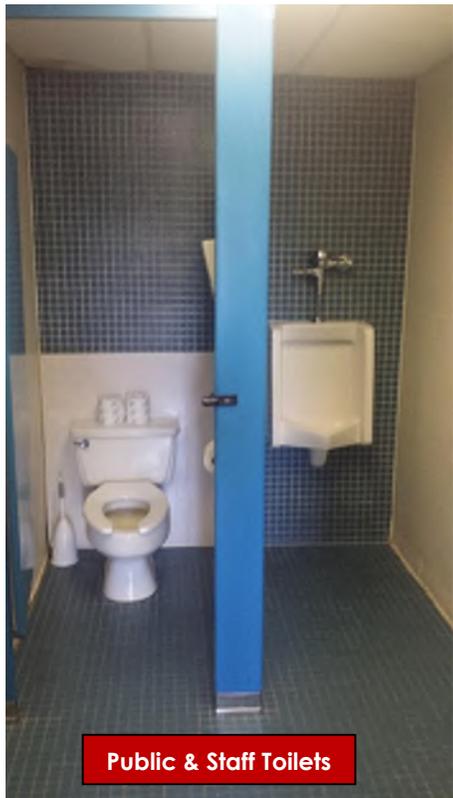
The existing toilets in the Lower Building are located next to the building entry. These are the only toilets in the Lower Building which must be used by both the public and the staff. In addition, neither the Men's or Women's toilet is ADA Accessible. Major renovation **and expansion** would be required to make these toilets accessible. All of the finishes and fixtures in the toilets should be replaced, including the following:

Public & Staff Toilets

- ✚ The 2" x 2" tile floor and wall tile needs to be replaced.
- ✚ The existing suspended acoustical ceiling is beyond its useful life and should be replaced.
- ✚ The existing fluorescent lighting should be replaced with energy efficient lighting.
- ✚ All the existing plumbing fixtures and toilet accessories should be replaced.
- ✚ The existing metal toilet partitions should be replaced.

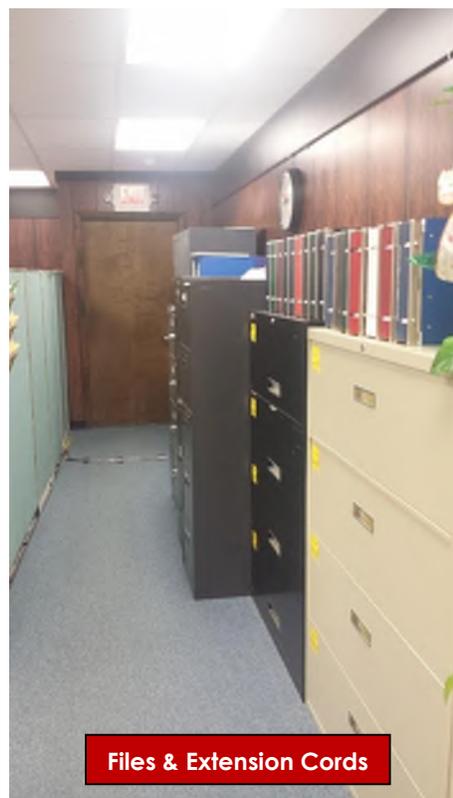
Files & Extension Cords

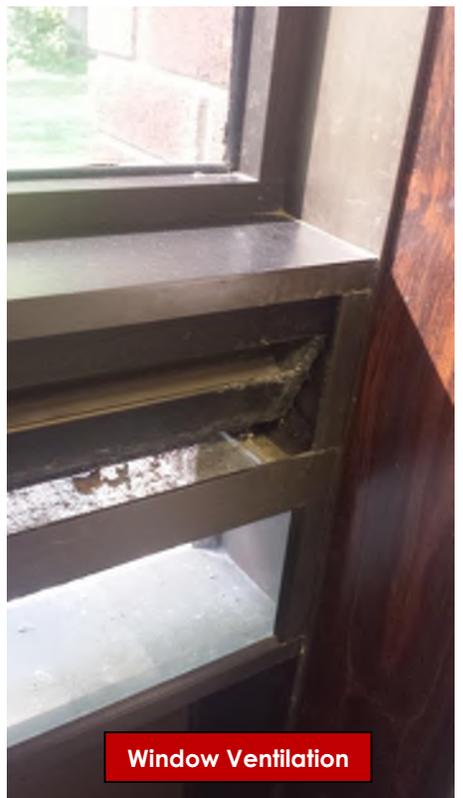
Window Ventilation

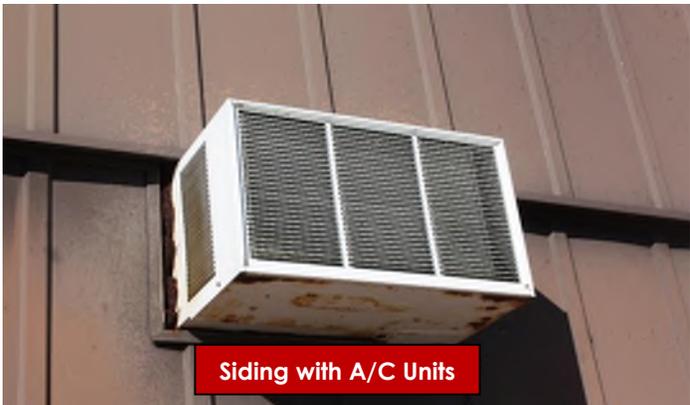
Siding with A/C Units

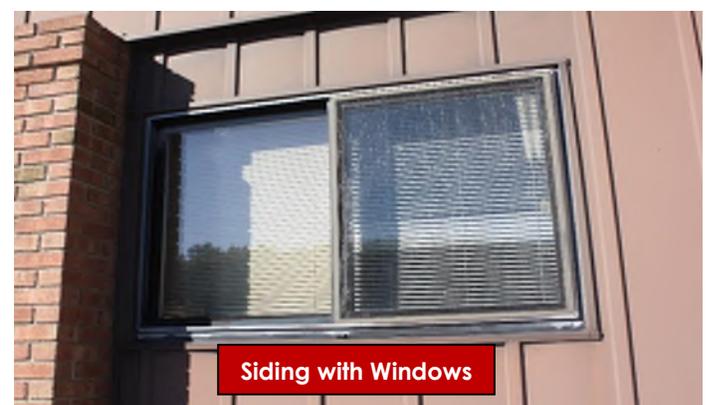
Siding with Windows

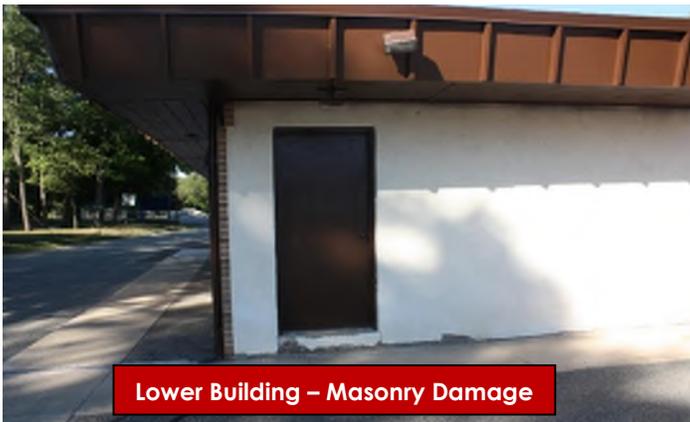
Lower Building – Masonry Damage

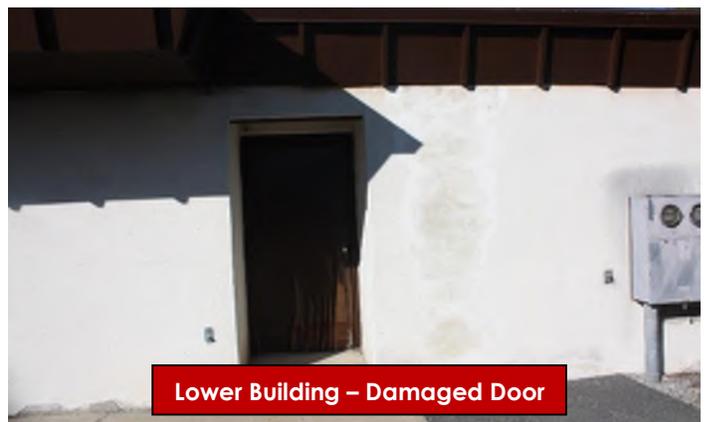
Lower Building – Damaged Door

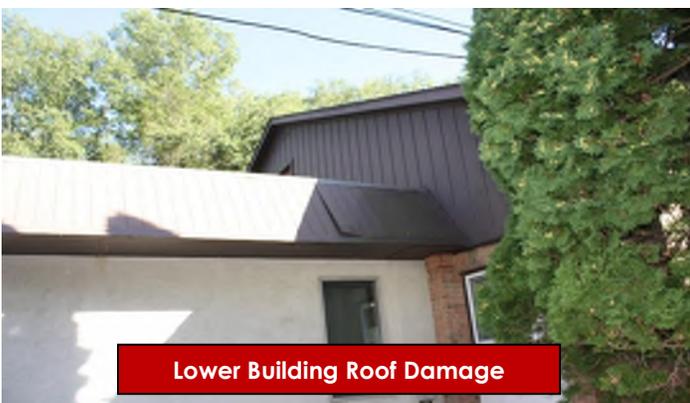
Lower Building Roof Damage

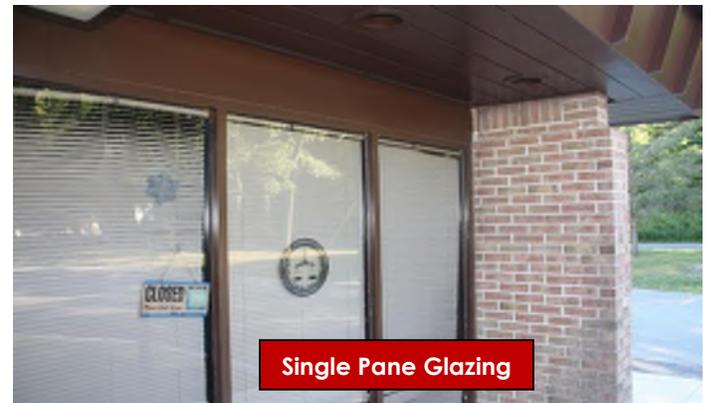
- ✚ A supplemental through-wall AC unit has been installed indicating that the existing HVAC system is not functioning as it should.
- ✚ The existing storefront, on the front building façade, is a single pane aluminum and glass system which should be replaced with new insulating glass units, and thermally broken aluminum frames.

Single Pane Glazing

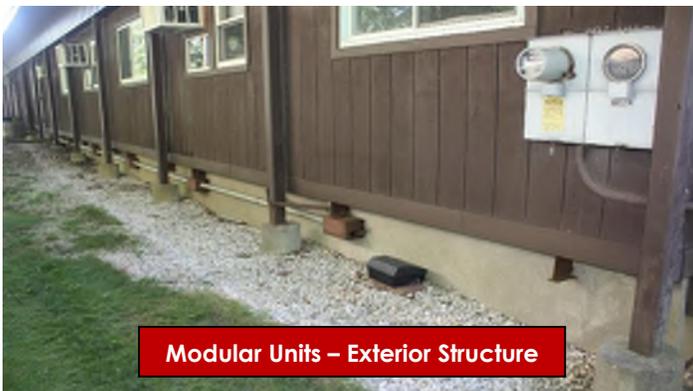
The useful life expectancy of modular units is from eight (8) to ten (10) years. The Upper Building was assembled forty (40) years ago in approximately 1975. As such this assembly of modular units is well beyond its useful life expectancy.

Modular Units – Exterior Structure
